**ASBESTOS CONTAINING BUILDING MATERIALS**  
**FOR NESHAP COMPLIENCE**

**Reference Structure:**  
**Located in the 200 S Center Street**  
**Municipal Government Complex**  
200 South Center Street  
Statesville NC 28677

Prepared For:  
Iredell County  
PO Box 788  
Statesville NC 28687

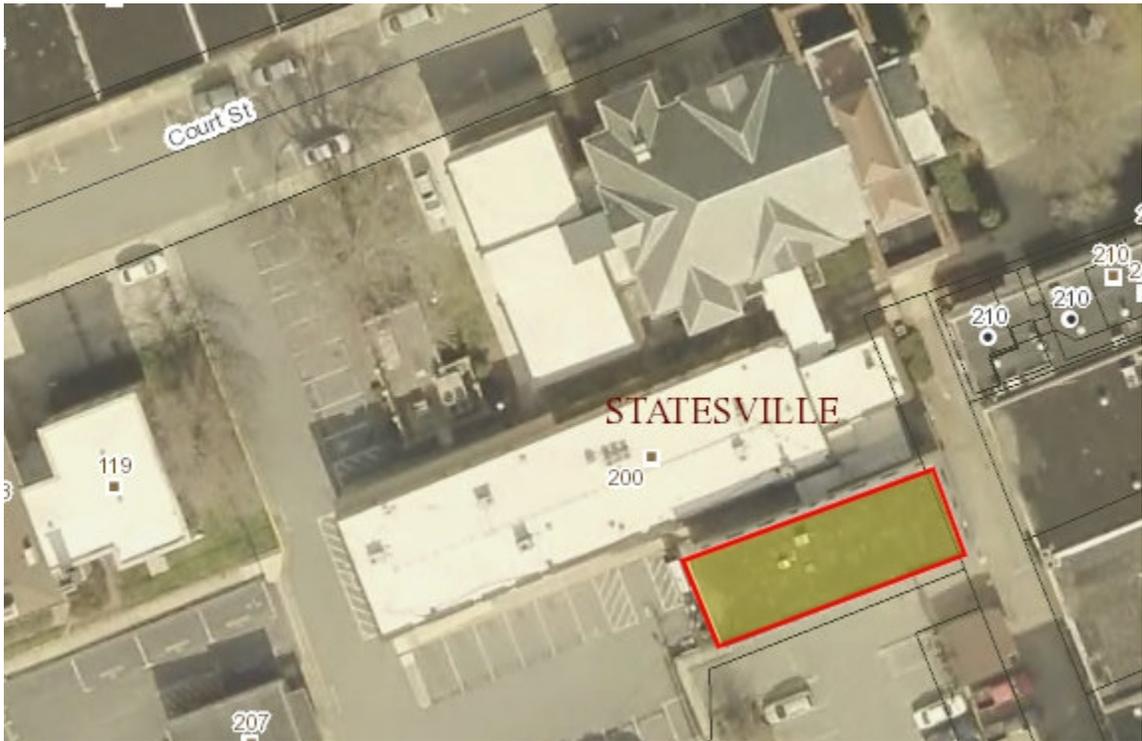
**The structure inspected is outlined in red due to it not having an independent address from the other buildings in the complex**

Iredell County Building Located at approximately 200 S Center Street Statesville NC
